# Stagehand Pro RS485 Upgrade

### Upgrading An A800

### Upgrading An A700

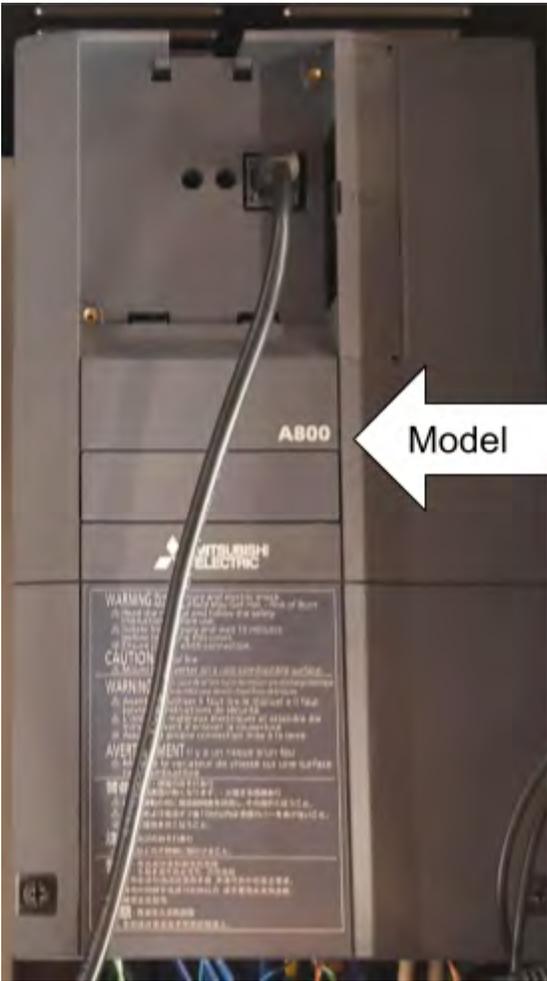
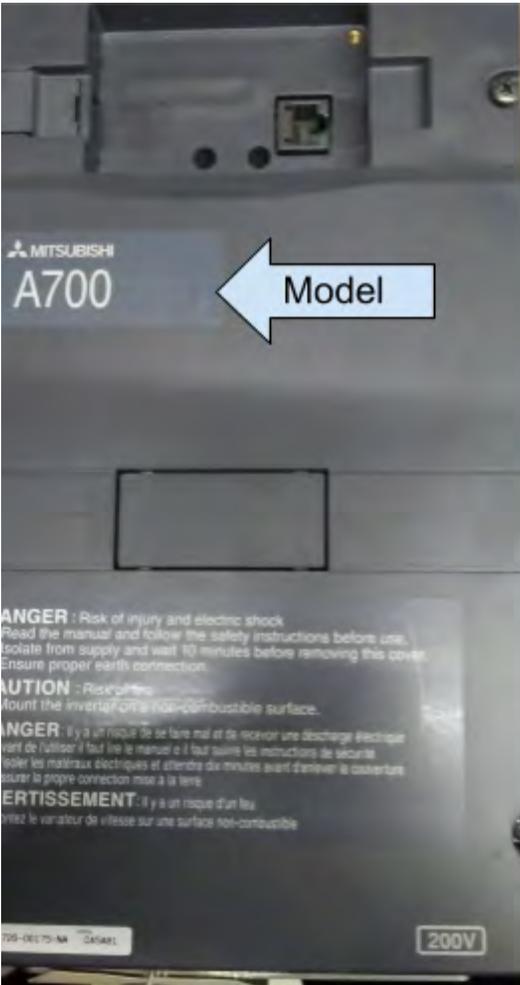
- 1. You will need the following to complete this upgrade
  - a. Stagehand Pro running v27 (or later) firmware
  - b. #2 Phillips head screwdriver
  - c. Small flathead screwdriver
  - d. Resistor kit (2 @ 680Ω)
  - e. A known working motor or machine
  - f. A computer running Spikemark 4.0
- 2. Unplug the Stagehand and lay it down on the big side that doesn't slide out.
- 3. Loosen the brass thumb screw on the top of the Stagehand, and slide out the side panel.
- 4. Look for the model number on the VFD (big grey box) It will either say **A800** or **A700**.

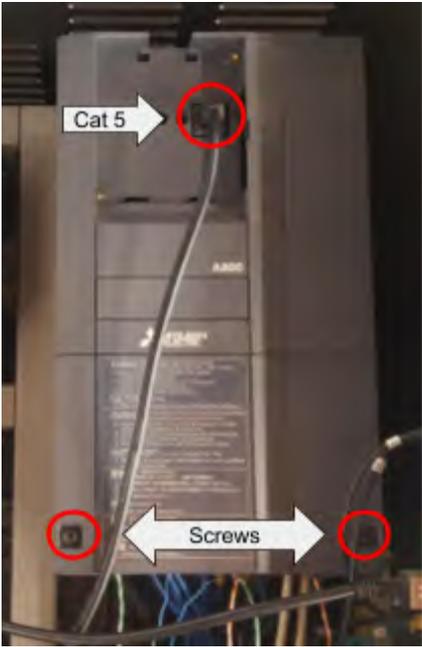
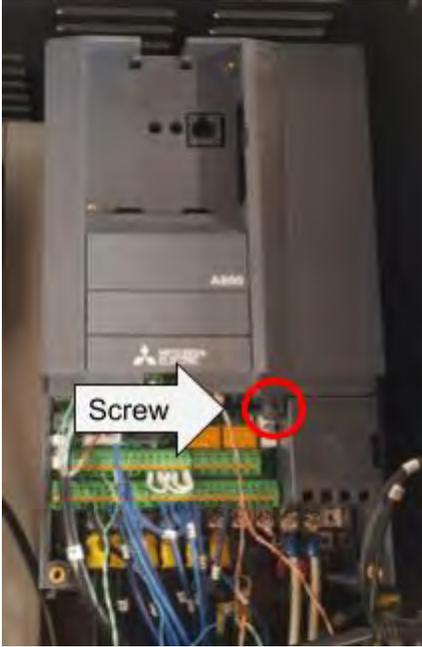
- 1. Unplug the Cat5 cable going into the VFD and remove the 2 screws holding on the lower cover.
- 2. Once the screws are loosened (they will not come out all the way out) gently pull up from the bottom of the cover to remove it.
- 3. Loosen the 1 screw holding in the upper cover.
- 4. Once the screw is loosened (it will not come out all the way out) gently pull up from the bottom of the cover to remove it.

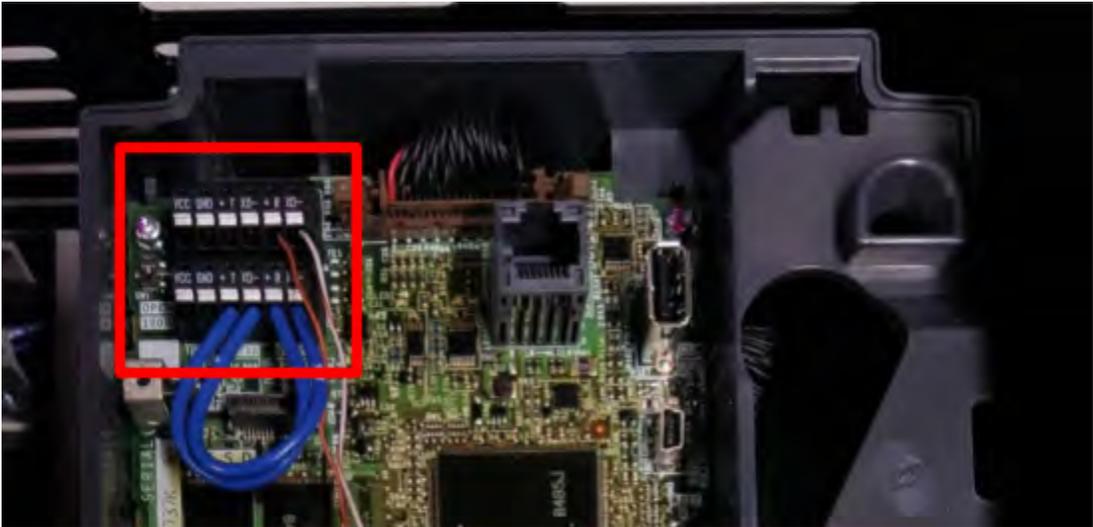
- 5. Look for the communication terminal blocks located at the top of the VFD

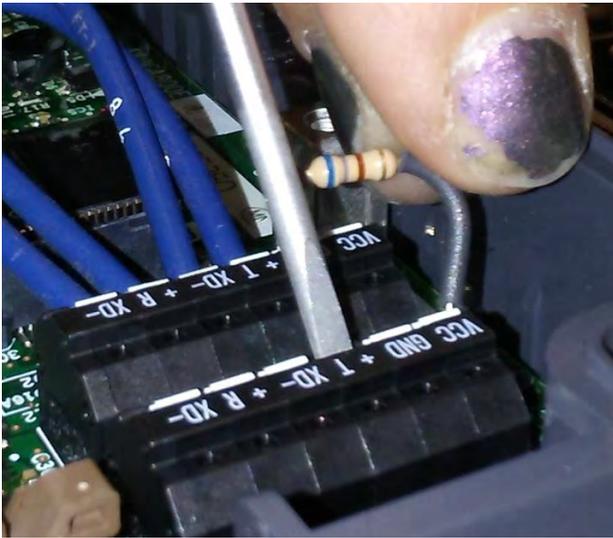
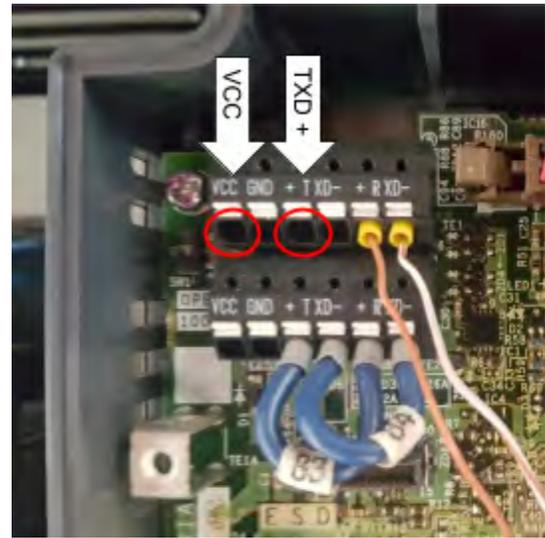
- Using a small screwdriver, press the white tabs above each terminal and insert a 680 $\Omega$  resistor between VCC and TXD +

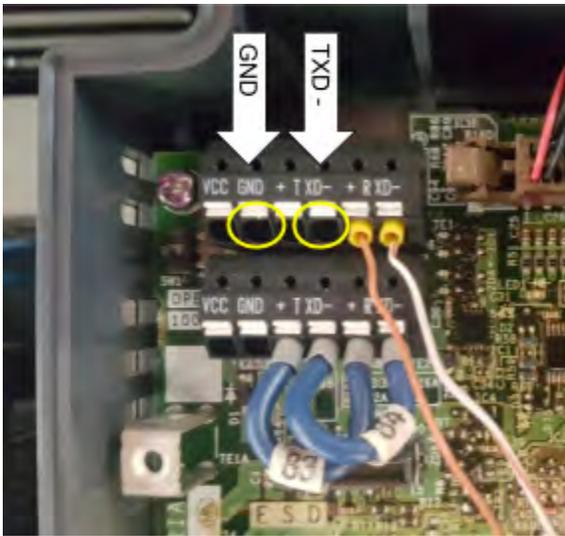
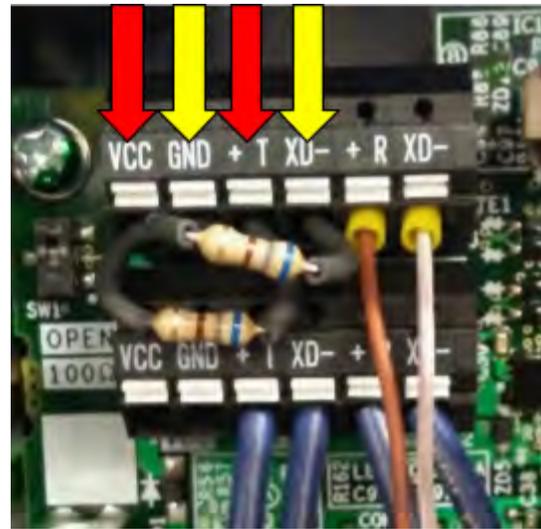
- Repeat to insert a 680 $\Omega$  resistor between GND and TXD-.

- IMPORTANT:** make sure the bare legs of the resistors are not touching each other. You should be able to gently tug on the resistors and they should not come out of the VFD.
- Confirm RDX discrete wiring connections:
  - RDX+ = BROWN
  - RDX- = WHITE with BROWN STRIPE

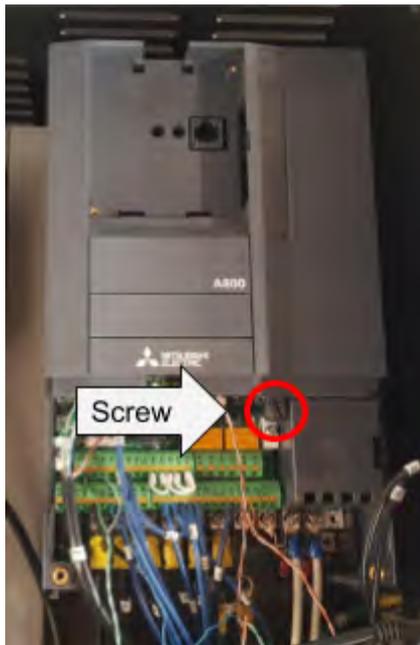
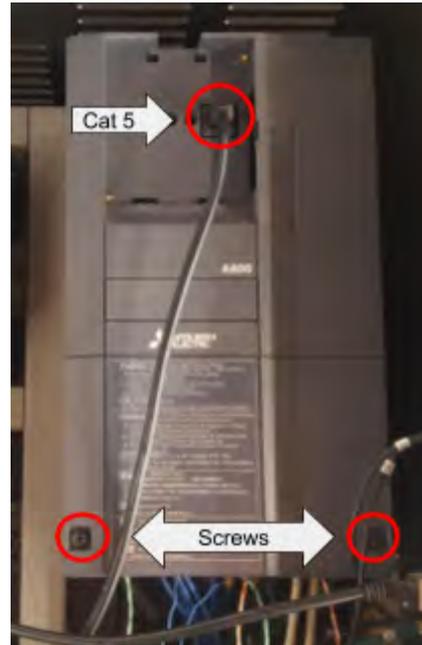
10. Replace upper VFD cover by snapping it into place and tightening the screw at the bottom.
11. Replace lower VFD cover by snapping it into place and tightening the 2 screws.

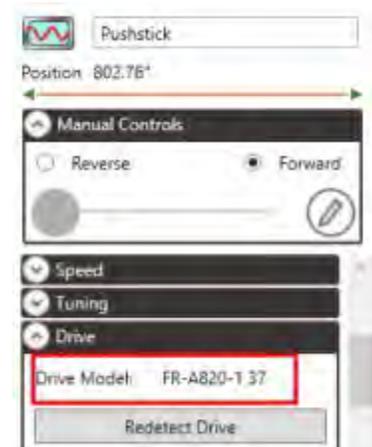
17. After making all the changes, cycle power to the VFD.
18. Open Spikemark 4.0, connect to the Stagehand.
19. Confirm that your Stagehand is running firmware version 27 or later.
20. In Spikemark, scroll down to the Drive section.
21. Next to Drive Model you should see **A800 Series**, or **FR-A8** followed by other letters and numbers. Your drive is now speaking to Spikemark!

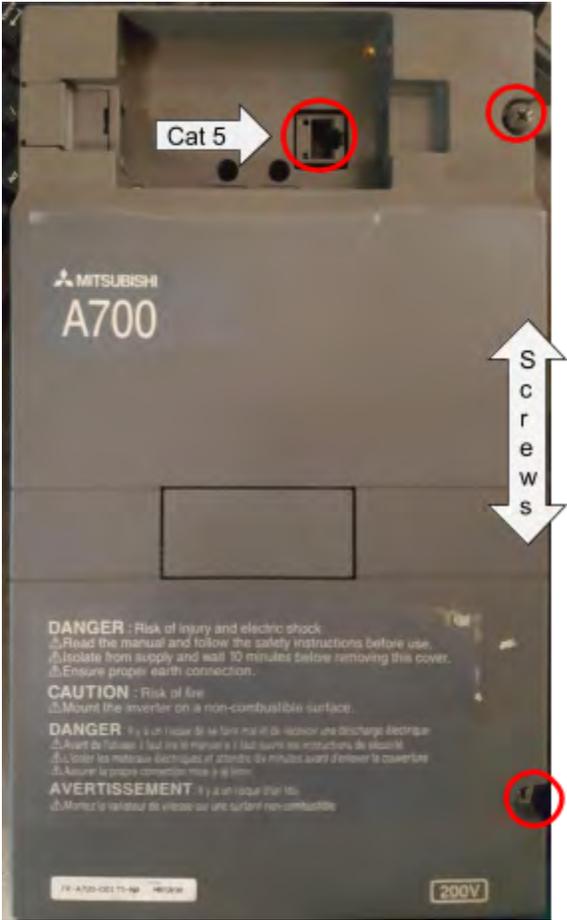
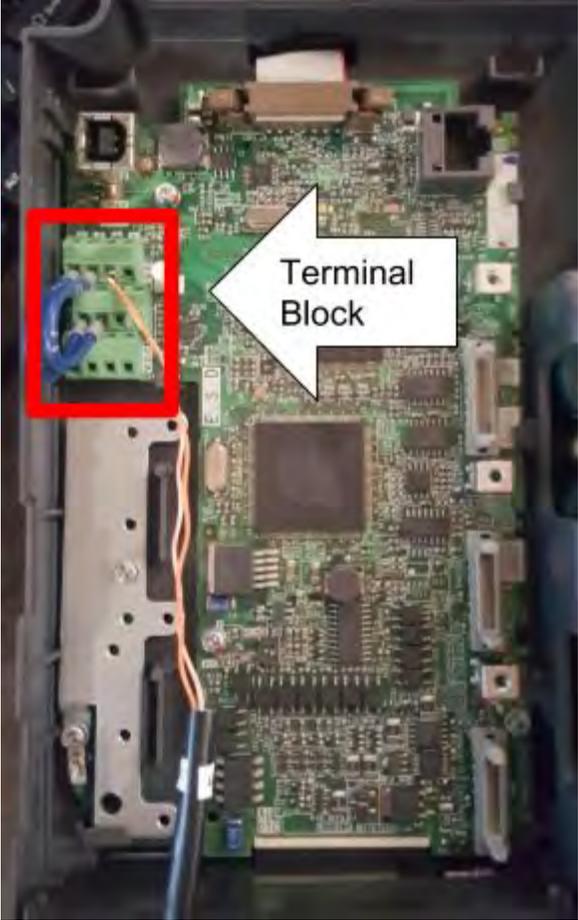
- 1. Unplug the Cat5 cable going into the VFD and remove the 2 screws holding on the cover.
- 2. Once the screws are loosened (they will not come all the way out) gently pull up from the side of the cover to remove it.

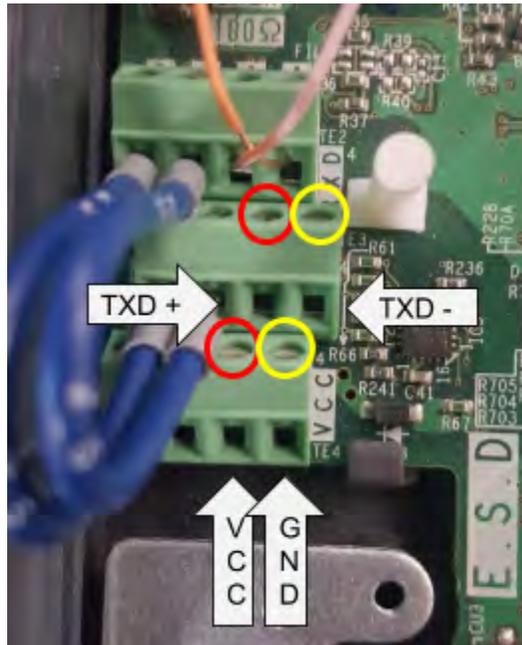
4. Using a small screwdriver, loosen the 4 screws circled below
  - a. The lower terminal block are the VCC and GND connections
  - b. The middle terminal block are the TXD+ and TXD- connections

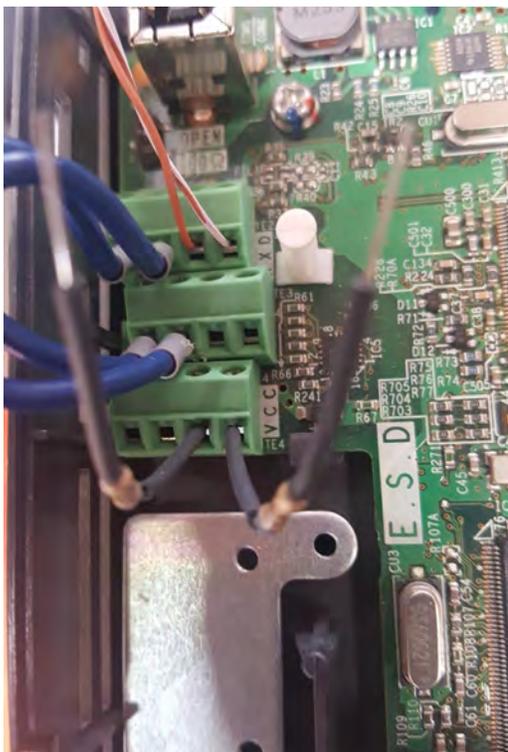
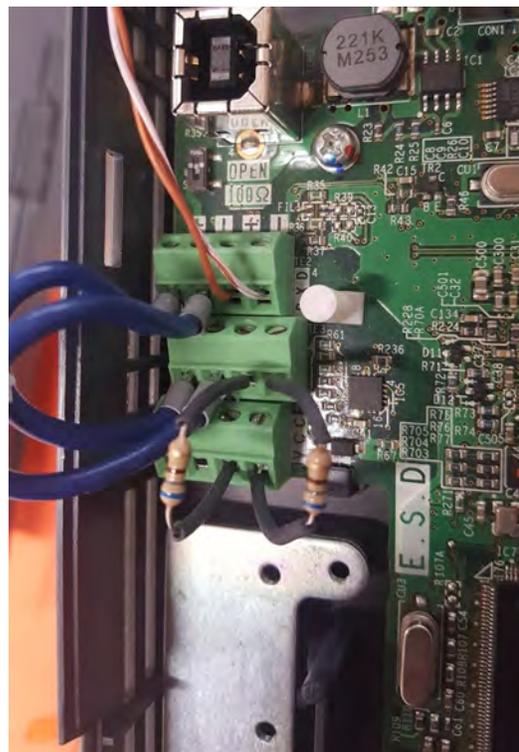
5. Insert one leg of the first 680Ω resistor into VCC and one leg of the second 680Ω resistor into GND and tighten the screws.
6. Connect the other side of the resistors:  
Insert the remaining leg from the resistor plugged into VCC into TXD +.  
Insert the remaining leg from the resistor plugged into GND into TXD -. Tighten down both screws

- a. make sure the resistors are not touching each other or any other components
  - b. the resistors should not cross
  - c. You should be able to gently tug on the resistors and they should not come out of the VFD.
8. Replace VFD cover by snapping it into place and screwing in the two screws

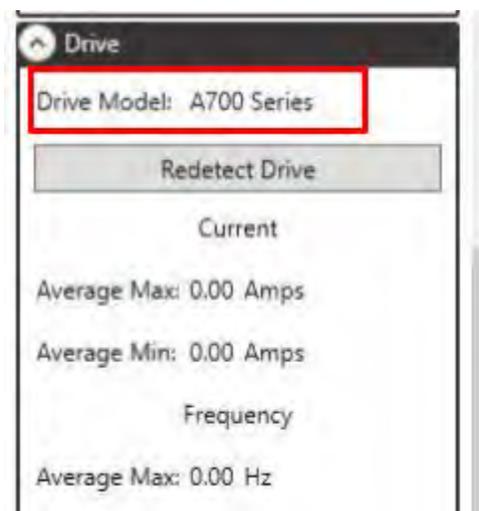
13. After making all the changes cycle power to the VFD
14. Open Spikemark 4.0, connect to the stagehand.
15. Confirm that your Stagehand is running firmware version 27 or later.
16. In Spikemark, scroll down to the drive section.
17. Next to Drive Model you should see either **A700 Series** or **FR-A7** followed by other letters and numbers. This means your Stagehand is talking to Spikemark!

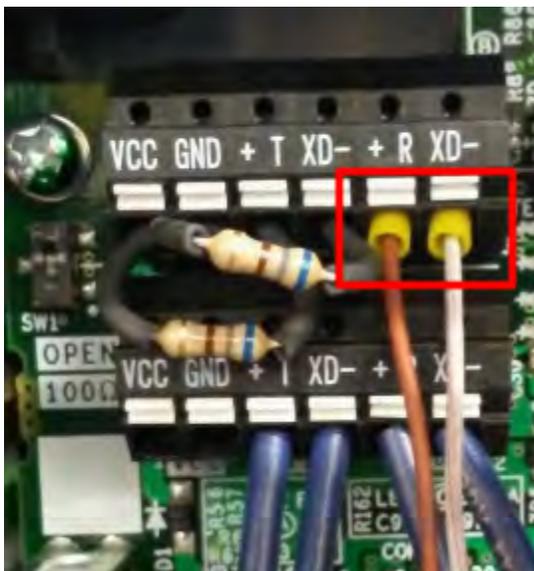
### A800 VFD

- A. VFD wont turn on
  - a. Double check that your resistors are not touching
- B. If drive model says undetectable
  - a. Double check you are running firmware 27 or above on the Stagehand
    - i. Update firmware through Spikemark 4.0 or later or with the Stagehand Updater Utility
  - b. Double check that you have one 680 $\Omega$  resistor going between TXD+ and VCC
  - c. Double check that you have one resistor going between TXD- and GND
  - d. Double check that you have inserted the resistors securely
  - e. Try swapping the wires going into RXD+ and RXD-
